**Tree Inventory, Assessment,
and
Protection Report**

**1101 Branham Lane
San Jose, CA 95018**

Tri Star Foods

August 25, 2021

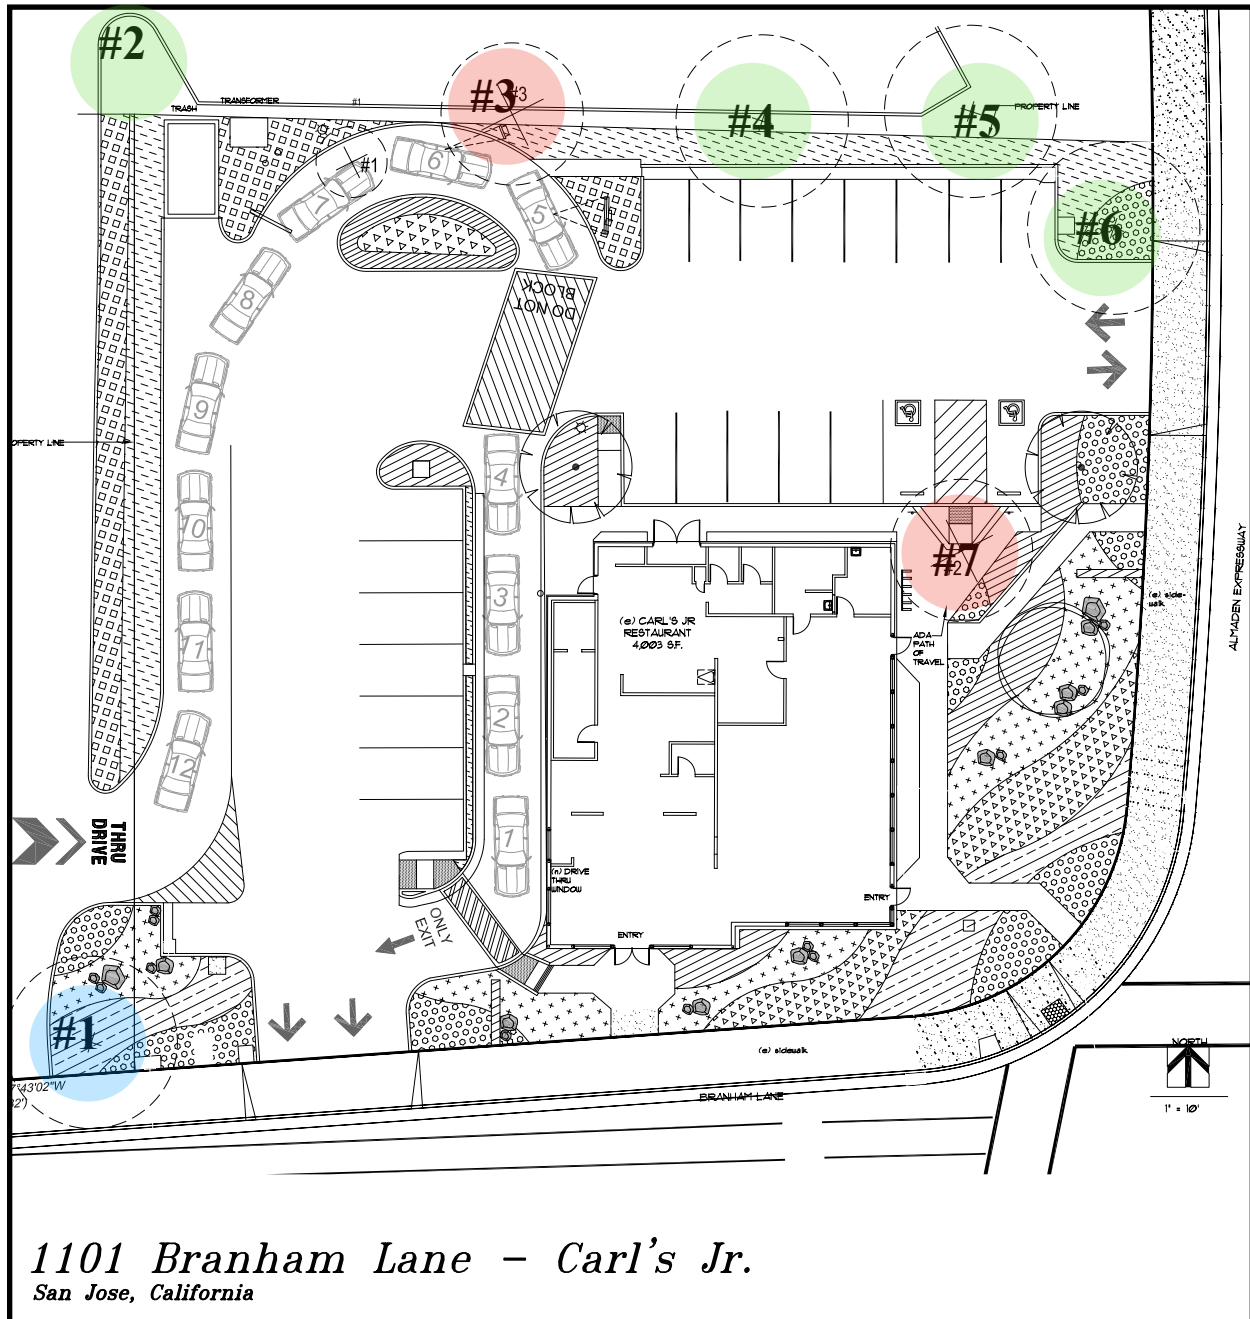
The landscape plan below, Sheet LP-1 provided by Jeorge Gutierrez date June 4, 2021. Trees #3 and #7 are to be removed, #1 should be considered for removal, and #2, #4, #5, and #6 will not be affected.

LANDSCAPE PLAN WITH TREE DISPOSITION IN RED (REMOVAL), GREEN (RETAIN), BLUE (CONSIDER REMOVAL).

There are two trees that will be highly impacted and caused to be removed. These include Shamel ash #3 in the parking lot, and Chinese pistache #7 against the building. Raywood ash #1 is in poor shape with poor suitability for preservation, the remaining two trees have fair suitability and Chinese pistache #7 is destroying the existing walkway on all sides (Appendix C). Raywood ash “Street Tree” #1 should be considered for removal and replacement.

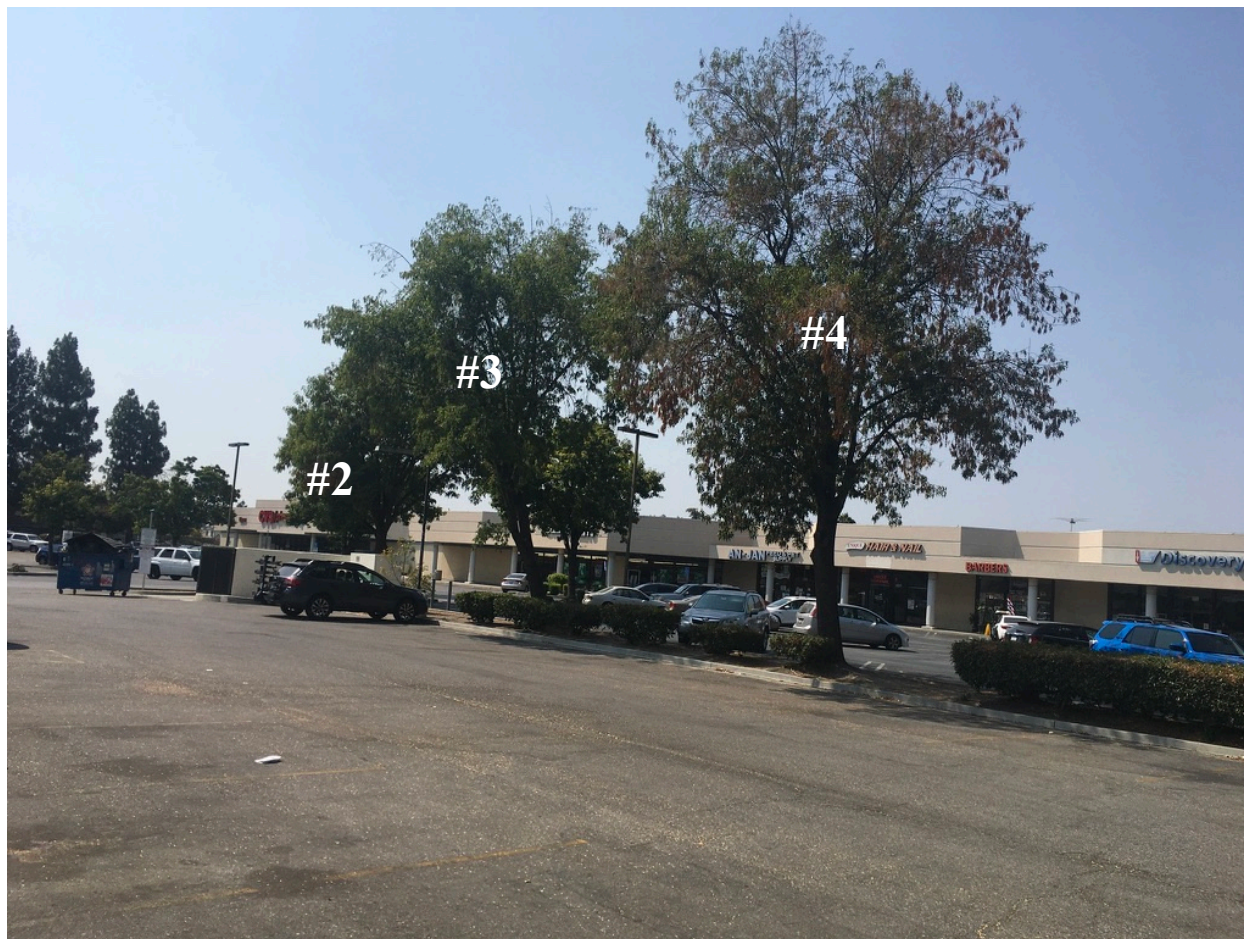
C2: Ash #2, #3, and #4

Two trees have poor suitability for preservation which are Raywood ash #1 and Shamel ash #3 due to their condition. The remaining trees have fair suitability for retention.
